Mask Set Errata 2
MC9S12D64* Microcontroller Unit
(*Devices covered: MC9S12D64 and MC9S12DJ64)

This errata provides information applicable to the following MCU mask set devices:

- 1L86D

MC9S12D64MSE2

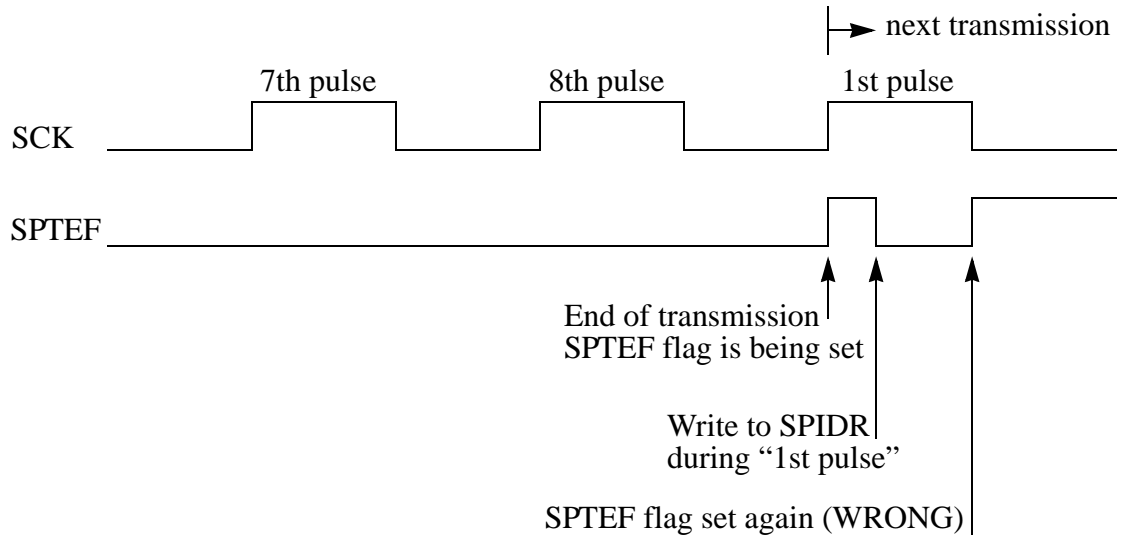
SPTEF FLAG SET WRONGLY**MUCTS00708**

When the SPI is enabled in master mode, with the CPHA bit set, back to back transmissions are possible.

When a transmission completes and a further byte is available in the SPI Data Register, the second transmission begins directly after the “minimum trailing time”.

The problem occurs when, after the SPTEF flag has been set, a further byte is written into the SPI Data Register during the “1st pulse” of a subsequent transmission.

Then the SPTEF flag is set at the falling SCK edge of the “1st pulse” and data is transferred from the SPI Data Register to the transmit shift register. The result is that the transmission is corrupted and data is lost.

After the SPTEF flag has been set, a delay of 1/2 SCK period has to be added before storing data into the SPI Data Register.
