*Mask Set Errata 3*  
**MC9S12D64\* Microcontroller Unit**  
(\*Devices covered: MC9S12D64 and MC9S12DJ64)

- 2L86D mask

**MC9S12D64MSE3**

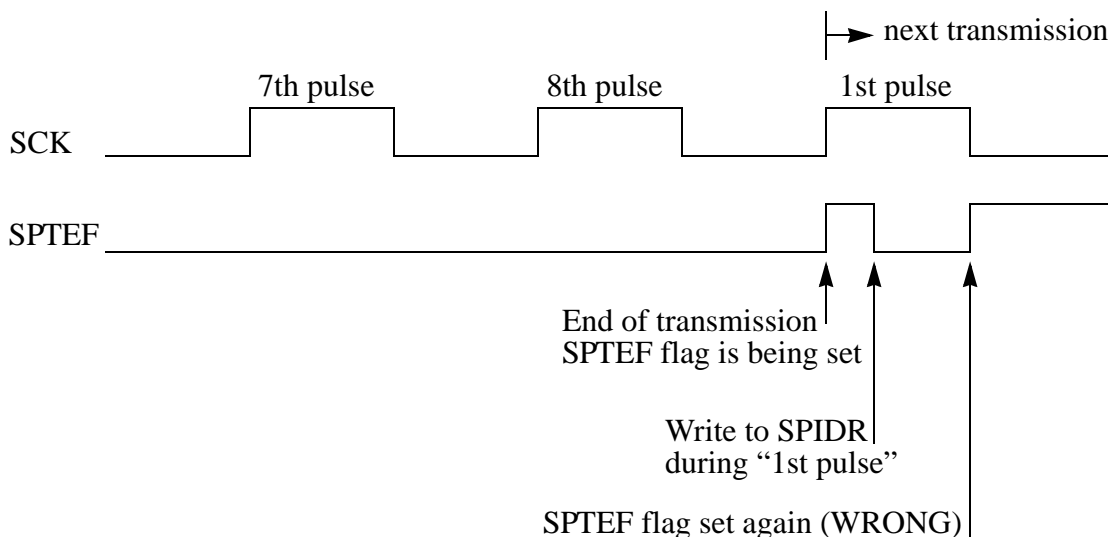
**SPTEF FLAG SET WRONGLY****MUCTS00708**

When the SPI is enabled in master mode, with the CPHA bit set, back to back transmissions are possible.

When a transmission completes and a further byte is available in the SPI Data Register, the second transmission begins directly after the “minimum trailing time”.

The problem occurs when, after the SPTEF flag has been set, a further byte is written into the SPI Data Register during the “1st pulse” of a subsequent transmission.

Then the SPTEF flag is set at the falling SCK edge of the “1st pulse” and data is transferred from the SPI Data Register to the transmit shift register. The result is that the transmission is corrupted and data is lost.

After the SPTEF flag has been set, a delay of 1/2 SCK period has to be added before storing data into the SPI Data Register.
