Mask Set Errata 2

MC9S12H256 Microcontroller Unit

- 1K78X mask of the MC9S12H256 and MC9S12H128

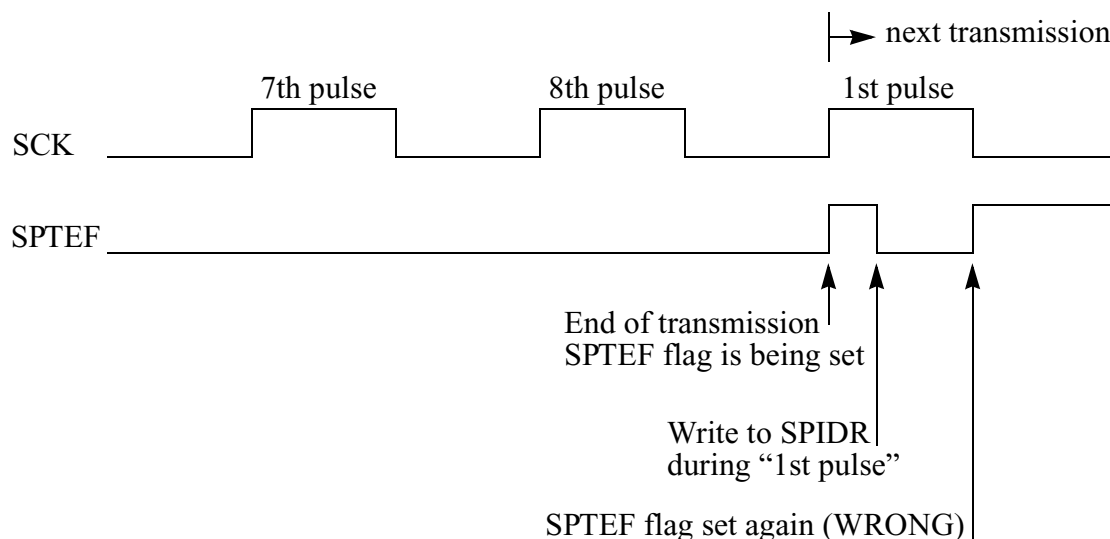
SPTEF FLAG SET WRONGLY**MUCTS00704**

When the SPI is enabled in master mode, with the CPHA bit set, back to back transmissions are possible.

When a transmission completes and a further byte is available in the SPI Data Register, the second transmission begins directly after the “minimum trailing time”.

The problem occurs when, after the SPTEF flag has been set, a further byte is written into the SPI Data Register during the “1st pulse” of a subsequent transmission .

Then the SPTEF flag is set at the falling SCK edge of the “1st pulse” and data is transferred from the SPI Data Register to the transmit shift register. The result is that the transmission is corrupted and data is lost.

After the SPTEF flag has been set, a delay of 1/2 SCK period has to be added before storing data into the SPI Data Register.
