Mask Set Errata

MSE912D60A_0L51J
Rev 0, 01/2003

Mask Set Errata for
68HC912D60A
Mask 0L51J

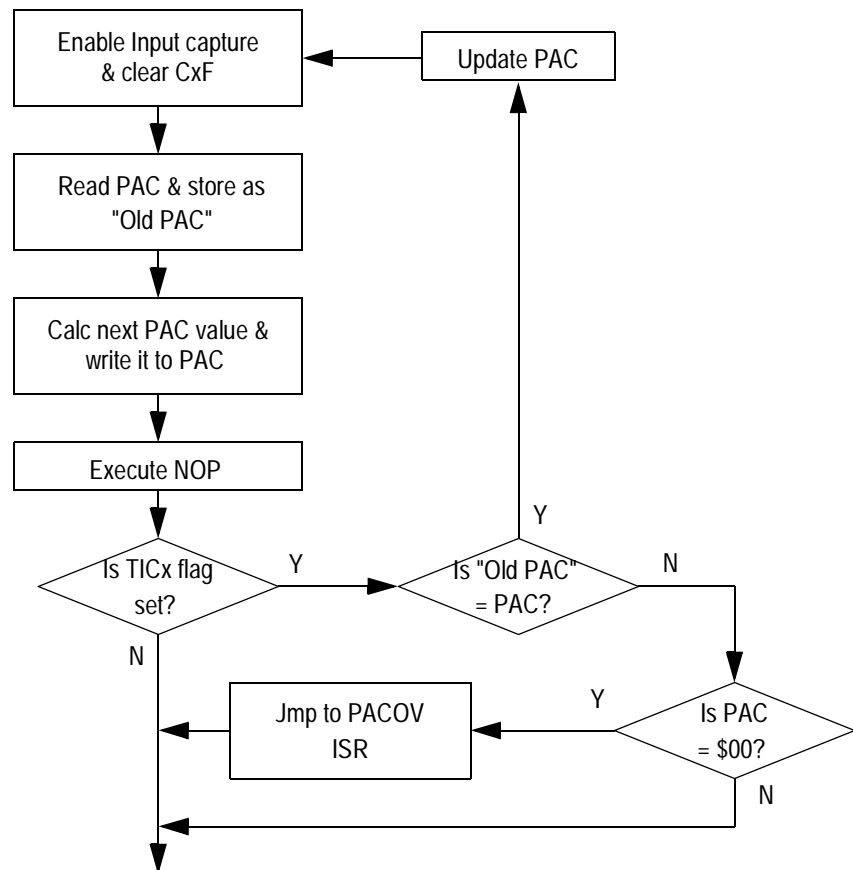
Description When the value \$FFFF is written to PACA or PACB and, at the same time, an external clocking pulse is applied to the PAC, the pulse accumulator may overflow from \$FFFF to \$0000, but the pulse accumulator overflow flag [PAFLG,PBFLG] is not set. Same situation may happen with 8-bit pulse accumulators PAC1 and PAC3.

Workaround The input capture function for the subject channel be enabled prior to writing a value to the PACA or PACB. Write to the pulse accumulator register. Then do one NOP (to allow the input capture to update the interrupt flag) followed by a read of the input capture interrupt flag to see if it set. If yes, a check must be made for a missing pulse accumulator event. Steps for software workaround to see if event happens while writing to PAC:

1. Enable Input Capture on same pin as the pulse accumulator (and same type of event).
2. Clear the appropriate CxF in the timer interrupt flag register.
3. Read PAC and store as "Old PAC".
4. Calculate desired PAC value and write it to the PAC.
5. Execute 1 NOP.
6. Read CxF in the timer interrupt flag register.
