Mask Set Errata

MSE912D60C_2L02H
Rev 0, 01/2003

Mask Set Errata for
68HC912D60C
Mask 2L02H

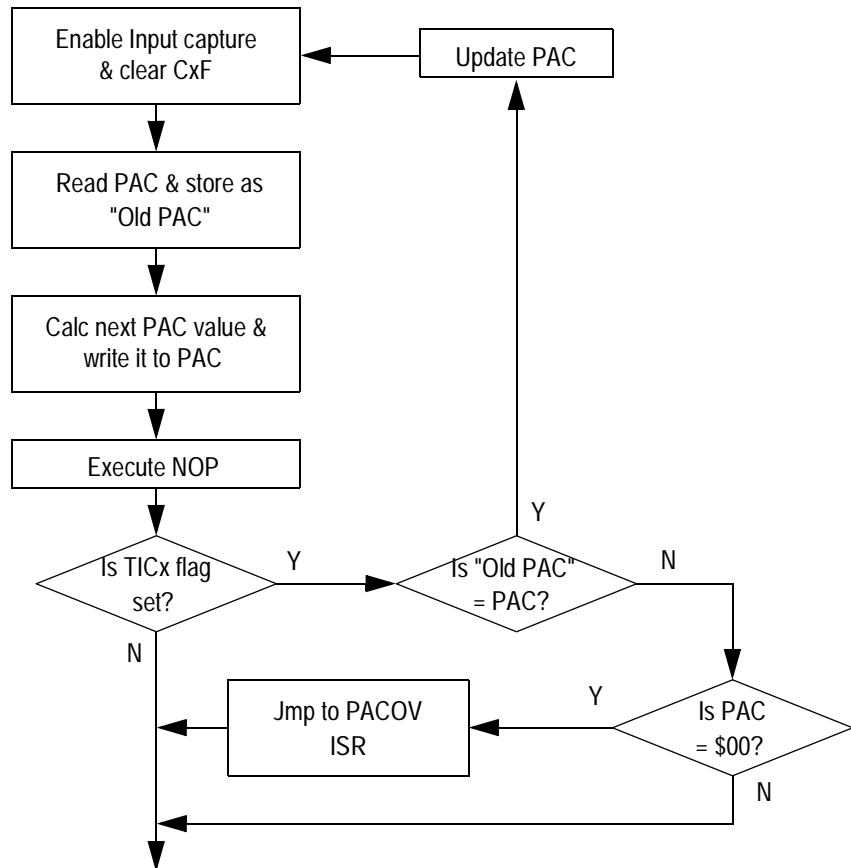
PA Overflow flag not set when event is concurrent with write of \$FFFF
Errata Number: HC12_AR_644
Description

When the value \$FFFF is written to PACA or PACB and, at the same time, an external clocking pulse is applied to the PAC, the pulse accumulator may overflow from \$FFFF to \$0000, but the pulse accumulator overflow flag [PAFLG,PBFLG] is not set. Same situation may happen with 8-bit pulse accumulators PAC1 and PAC3.

The input capture function for the subject channel be enabled prior to writing a value to the PACA or PACB. Write to the pulse accumulator register. Then do one NOP (to allow the input capture to update the interrupt flag) followed by a read of the input capture interrupt flag to see if it set. If yes, a check must be made for a missing pulse accumulator event. Steps for software workaround to see if event happens while writing to PAC:

1. Enable Input Capture on same pin as the pulse accumulator (and same type of event).
2. Clear the appropriate CxF in the timer interrupt flag register.
3. Read PAC and store as "Old PAC".
4. Calculate desired PAC value and write it to the PAC.
5. Execute 1 NOP.
6. Read CxF in the timer interrupt flag register.

If flag is not set, done (no events happened while writing to the PAC).

If flag is set read PAC

If "Old PAC" = PAC, then update PAC (event happened while writing to PAC and the PAC did not capture it). Note, if the updated PAC value is \$00 jump to PACOV ISR.

If "Old PAC" does not equal PAC, does PAC = \$00 ?

If yes, jump to PACOV ISR.

If no, done (event happened while writing to the PAC and PAC captured it). Read CxF in the timer interrupt.
