Mask Set Errata

MSE912DG128A_0L05H
Rev 0.0, 01/2003

Mask Set Errata for
68HC912DG128A
Mask 0L05H

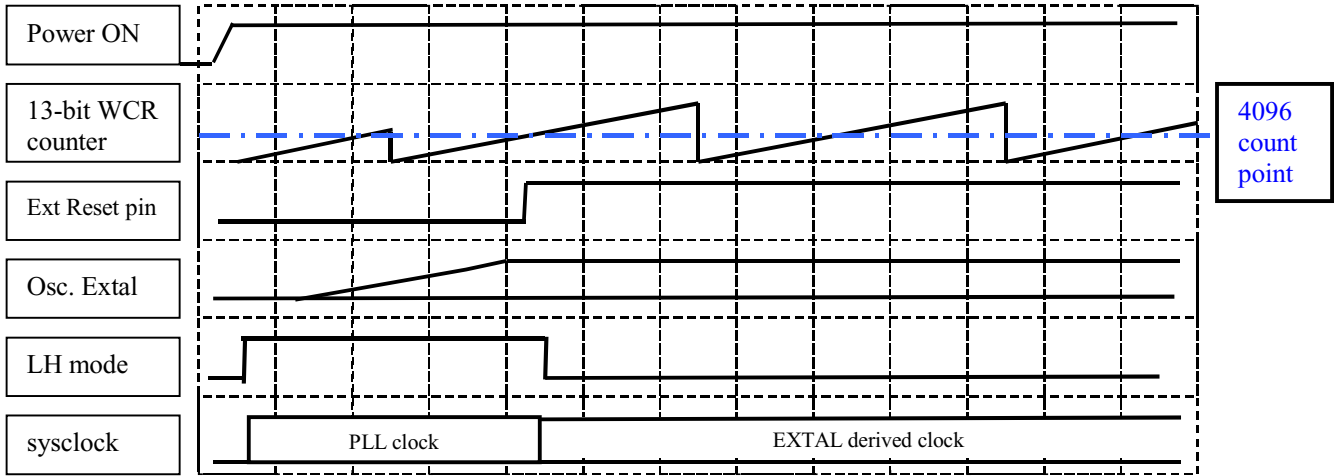
Figure 1. Representation of Normal start-up condition

Common practice for the start up mode of operation of HC12 microcontrollers is for the external RESET line to be held active until such time as the crystal has stabilized at its operating frequency. On release of the external RESET line and when the WCR (counter register) reaches a count of 4096 cycles, normal operating mode is entered with the CPU clocked from the crystal frequency (see fig. 1).

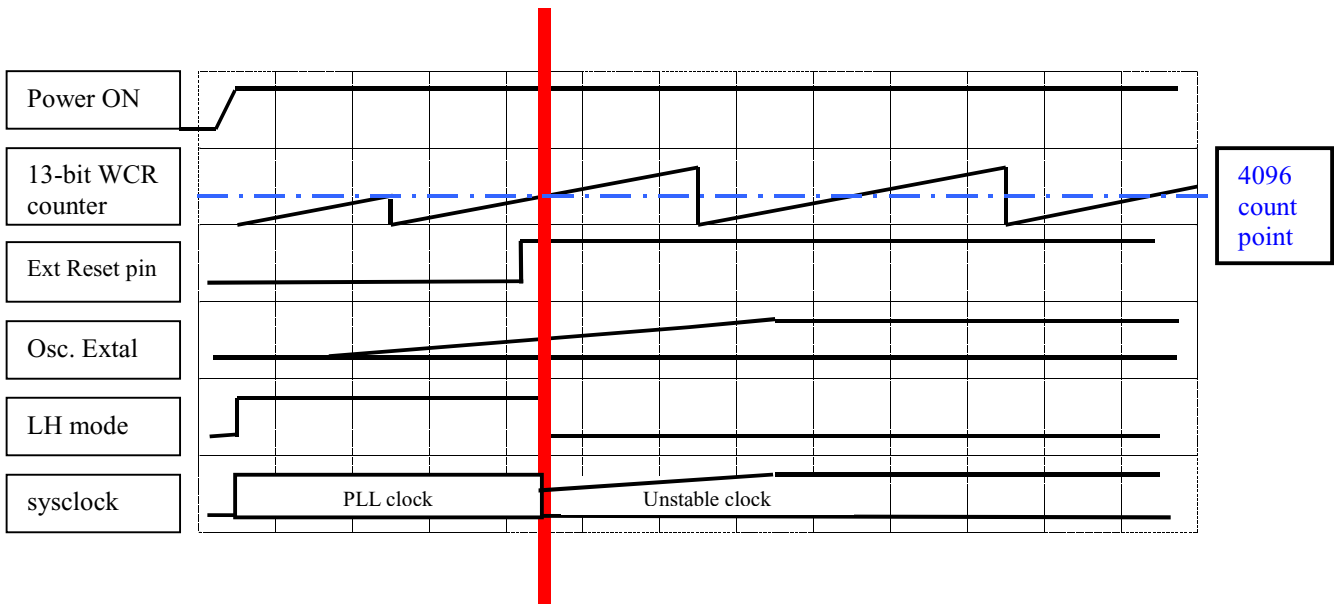
Figure 2. Representation of unreliable start-up mode with slow crystal

The device can prematurely indicate that the oscillator has stabilized releasing the part from Limp Home clock mode to the oscillator clock mode with an unstable oscillator. This can cause unpredictable behavior of the MCU. This situation can arise with short external power-on reset periods and / or crystal oscillator circuits that exhibit slow startup characteristics. If the PLL is not being used (Vddpll connected to Vss) Limp Home mode is disabled and this issue does not apply.

For the first 4096 cycles i.e. during the internal reset period, Limp Home mode will be de-asserted if oscillator activity is detected by the clock monitor circuit - due to the asserted Reset signal there can be no CPU activity during the Reset phase. Following release of the external or internal POR RESET in LHM (whichever is later) the crystal oscillator is sampled by the clock monitor circuit after another 4096 VCO clock cycles and at intervals of 8192 clock cycles thereafter until the crystal is deemed to be operating. If the crystal oscillator is showing activity at the time it is checked then it will be deemed to be good, even though it may not have fully stabilized, and LHM will be de-asserted. This can cause the device to switch from LH mode to normal mode with the CPU clocked from an unstable signal from the crystal oscillator (see fig. 2) resulting in unpredictable function of the CPU.

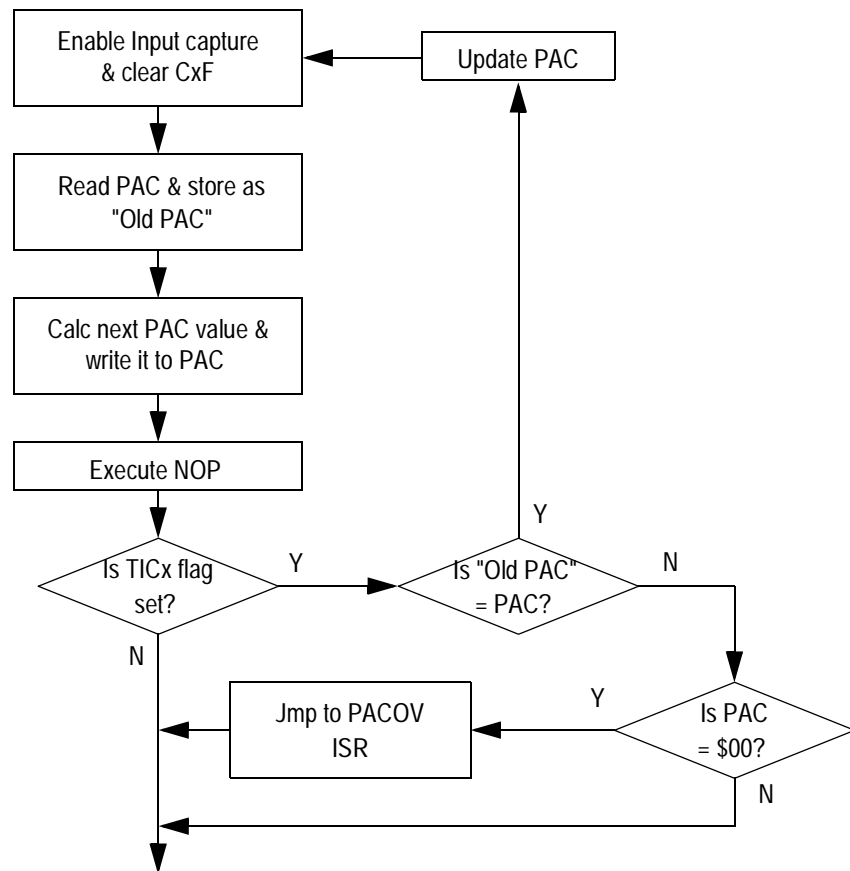
Description When the value \$FFFF is written to PACA or PACB and, at the same time, an external clocking pulse is applied to the PAC, the pulse accumulator may overflow from \$FFFF to \$0000, but the pulse accumulator overflow flag [PAFLG,PBFLG] is not set. Same situation may happen with 8-bit pulse accumulators PAC1 and PAC3.

Workaround The input capture function for the subject channel be enabled prior to writing a value to the PACA or PACB. Write to the pulse accumulator register. Then do one NOP (to allow the input capture to update the interrupt flag) followed by a read of the input capture interrupt flag to see if it set. If yes, a check must be made for a missing pulse accumulator event. Steps for software workaround to see if event happens while writing to PAC:

1. Enable Input Capture on same pin as the pulse accumulator (and same type of event).
2. Clear the appropriate CxF in the timer interrupt flag register.
3. Read PAC and store as "Old PAC".
4. Calculate desired PAC value and write it to the PAC.
5. Execute 1 NOP.
6. Read CxF in the timer interrupt flag register.
