Mask Set Errata

MSE912DG128C_1L05H
Rev 0.0, 01/2003

Mask Set Errata for
68HC912DG128C
Mask 1L05H

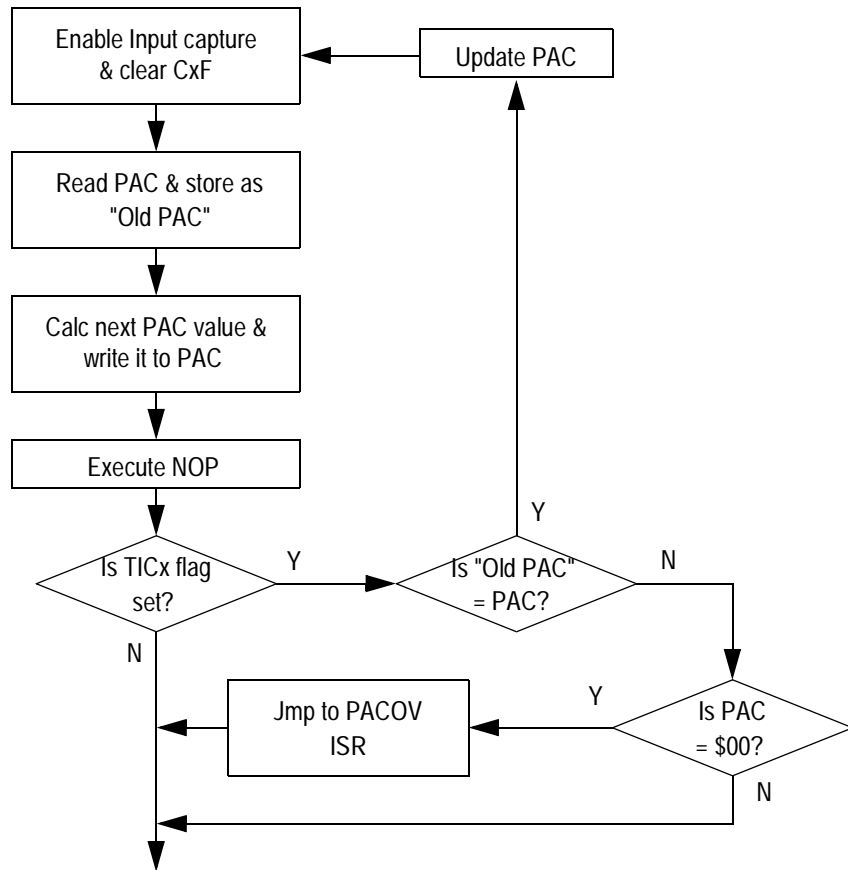
PA Overflow flag not set when event is concurrent with write of \$FFFF
Errata Number: HC12_AR_644

Description When the value \$FFFF is written to PACA or PACB and, at the same time, an external clocking pulse is applied to the PAC, the pulse accumulator may overflow from \$FFFF to \$0000, but the pulse accumulator overflow flag [PAFLG,PBFLG] is not set. Same situation may happen with 8-bit pulse accumulators PAC1 and PAC3.

Workaround The input capture function for the subject channel be enabled prior to writing a value to the PACA or PACB. Write to the pulse accumulator register. Then do one NOP (to allow the input capture to update the interrupt flag) followed by a read of the input capture interrupt flag to see if it set. If yes, a check must be made for a missing pulse accumulator event. Steps for software workaround to see if event happens while writing to PAC:

1. Enable Input Capture on same pin as the pulse accumulator (and same type of event).
2. Clear the appropriate CxF in the timer interrupt flag register.
3. Read PAC and store as "Old PAC".
4. Calculate desired PAC value and write it to the PAC.
5. Execute 1 NOP.
6. Read CxF in the timer interrupt flag register.

If flag is not set, done (no events happened while writing to the PAC).

If flag is set read PAC

If "Old PAC" = PAC, then update PAC (event happened while writing to PAC and the PAC did not capture it). Note, if the updated PAC value is \$00 jump to PACOV ISR.

If "Old PAC" does not equal PAC, does PAC = \$00 ?

If yes, jump to PACOV ISR.

If no, done (event happened while writing to the PAC and PAC captured it). Read CxF in the timer interrupt.
