Mask Set Errata

MSE912DT128A_0L05H
Rev 0.0, 01/2003

Mask Set Errata for
68HC912DT128A
Mask 0L05H

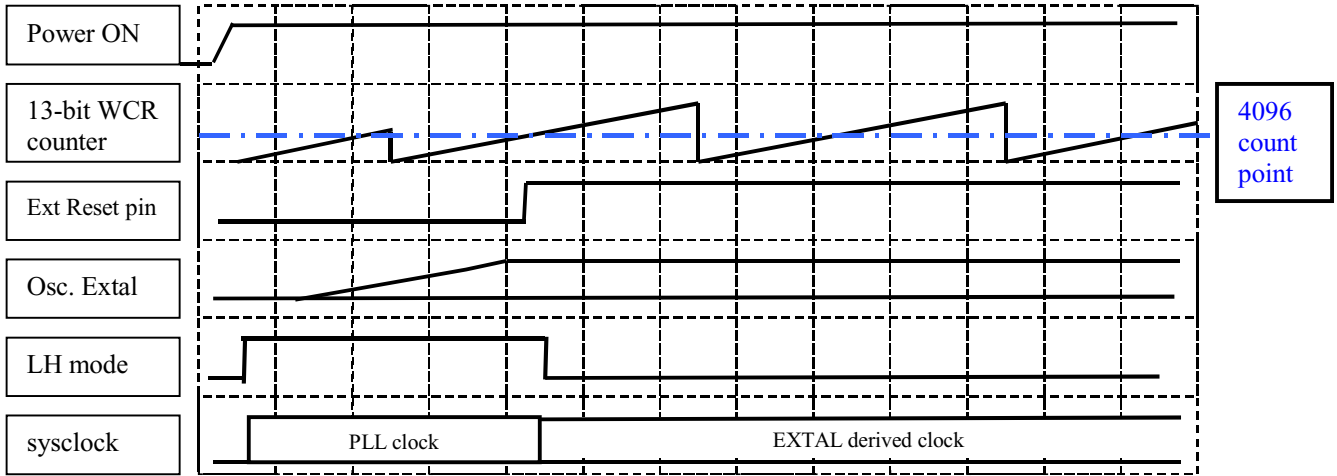
Common practice for the start up mode of operation of HC12 microcontrollers is for the external RESET line to be held active until such time as the crystal has stabilized at its operating frequency. On release of the external RESET line and when the WCR (counter register) reaches a count of 4096 cycles, normal operating mode is entered with the CPU clocked from the crystal frequency (see fig. 1).

Figure 1. Representation of Normal start-up condition

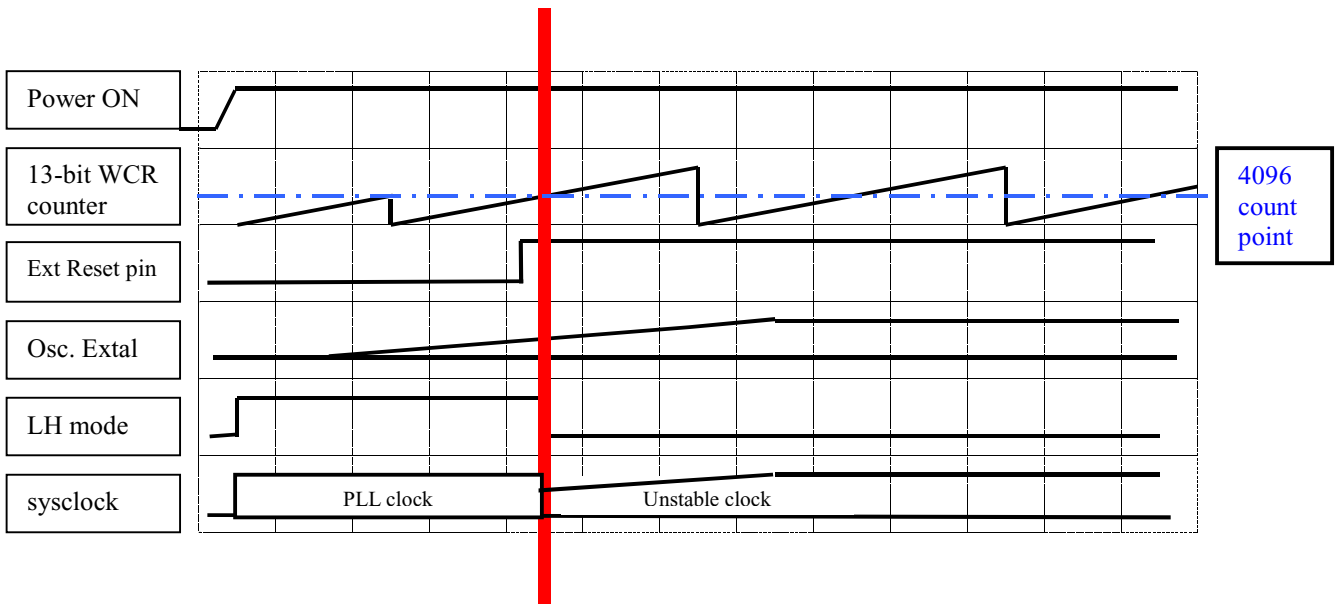
The HC12 mode of operation known as Limp-Home Mode (LHM) is enabled when the VDDPLL pin is at VDD and is entered if for any reason the external crystal ceases to oscillate. During this mode the CPU will be clocked from the free-running VCO clock of the PLL (at a nominal frequency of 1MHz). If LHM is enabled during the start-up phase (i.e. VDDPLL=5V, NOLHM bit=0) and the external RESET line is not held active until after the crystal frequency is stable then the device starts up in LHM since no crystal oscillations will be detected. This situation can arise with short reset periods and/or crystals that exhibit slow start-up characteristics.

For the first 4096 cycles i.e. during the internal reset period, Limp Home mode will be de-asserted if oscillator activity is detected by the clock monitor circuit - due to the asserted Reset signal there can be no CPU activity during the Reset phase. Following release of the external or internal POR RESET in LHM (whichever is later) the crystal oscillator is sampled by the clock monitor circuit after another 4096 VCO clock cycles and at intervals of 8192 clock cycles thereafter until the crystal is deemed to be operating. If the crystal oscillator is showing activity at the time it is checked then it will be deemed to be good, even though it may not have fully stabilized, and LHM will be de-asserted. This can cause the device to switch from LH mode to normal mode with the CPU clocked from an unstable signal from the crystal oscillator (see fig. 2) resulting in unpredictable function of the CPU.

Figure 2. Representation of unreliable start-up mode with slow crystal

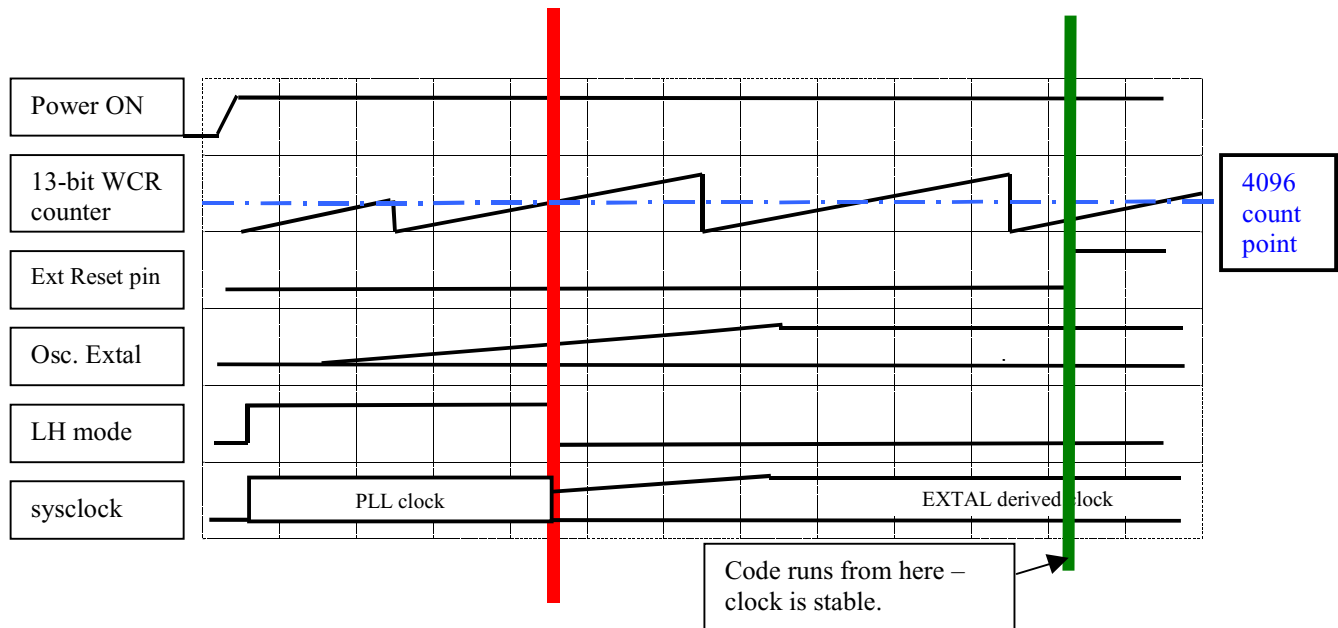
Figure 3. Representation of preferred means of overcoming issue with Figure 2

The Reset condition can be overcome by allowing the crystal oscillator circuit to stabilize before releasing the external RESET line (see fig. 3). Operation is similar to that shown in fig 2.

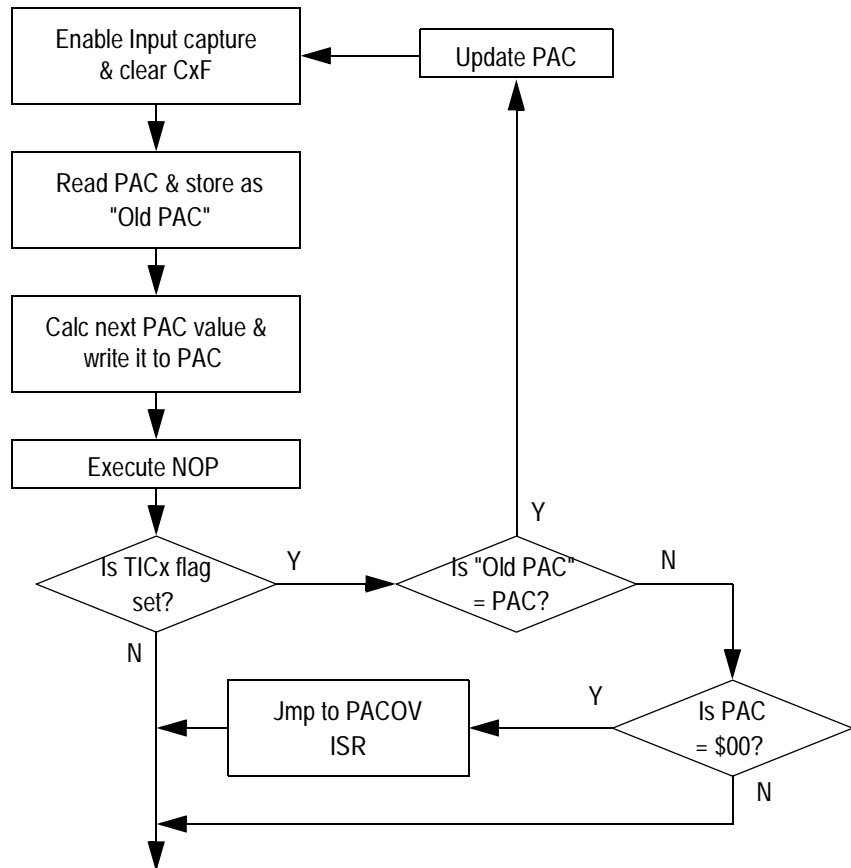
Description When the value \$FFFF is written to PACA or PACB and, at the same time, an external clocking pulse is applied to the PAC, the pulse accumulator may overflow from \$FFFF to \$0000, but the pulse accumulator overflow flag [PAFLG,PBFLG] is not set. Same situation may happen with 8-bit pulse accumulators PAC1 and PAC3.

Workaround The input capture function for the subject channel be enabled prior to writing a value to the PACA or PACB. Write to the pulse accumulator register. Then do one NOP (to allow the input capture to update the interrupt flag) followed by a read of the input capture interrupt flag to see if it set. If yes, a check must be made for a missing pulse accumulator event. Steps for software workaround to see if event happens while writing to PAC:

1. Enable Input Capture on same pin as the pulse accumulator (and same type of event).
2. Clear the appropriate CxF in the timer interrupt flag register.
3. Read PAC and store as "Old PAC".
4. Calculate desired PAC value and write it to the PAC.
5. Execute 1 NOP.
6. Read CxF in the timer interrupt flag register.
