Mask Set Errata

MSE9S12D128_1L40K
Rev 0.0, 03/2003

Mask Set Errata for
MC9S12DT128
Mask 1L40K

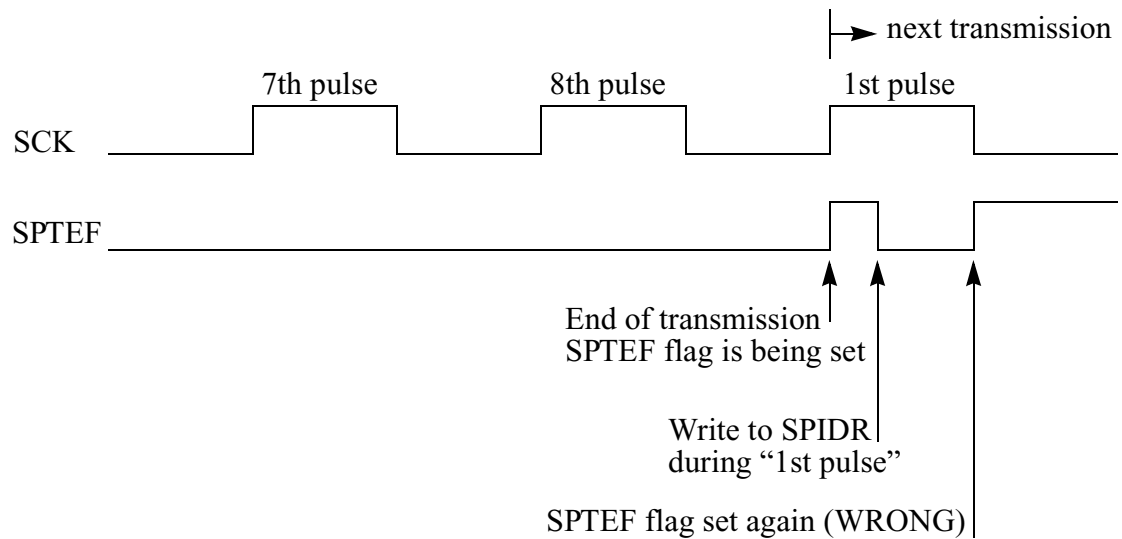
SPTEF flag set wrongly
Errata Number: MUCts00708
Description

The problem occurs when, after the SPTEF flag has been set, a further byte is written into the SPI Data Register during the "1st pulse" of a subsequent transmission.

Then the SPTEF flag is set at the falling SCK edge of the “1st pulse” and data is transferred from the SPI Data Register to the transmit shift register. The result is that the transmission is corrupted and data is lost.

After the SPTEF flag has been set, a delay of 1/2 SCK period has to be added before storing data into the SPI Data Register.
