Mask Set Errata

MSE9S12D128_3L40K
Rev 0, 03/2003

Mask Set Errata for
MC9S12DT128
Mask 3L40K

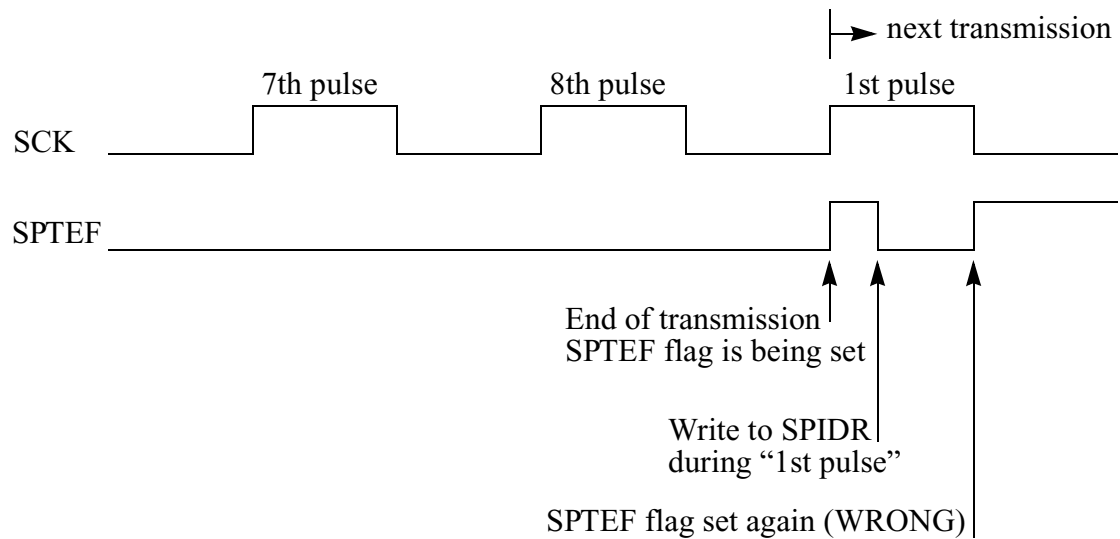
SPTEF flag set wrongly
Errata Number: MUCts00708
Description

The problem occurs when, after the SPTEF flag has been set, a further byte is written into the SPI Data Register during the “1st pulse” of a subsequent transmission.

Then the SPTEF flag is set at the falling SCK edge of the “1st pulse” and data is transferred from the SPI Data Register to the transmit shift register. The result is that the transmission is corrupted and data is lost.

After the SPTEF flag has been set, a delay of 1/2 SCK period has to be added before storing data into the SPI Data Register.
