Mask Set Errata 1
PC9S12D64* Microcontroller Unit
(*Devices covered: PC9S12D64 and PC9S12DJ64)

This errata provides information applicable to the following MCU mask set devices:

- 0L86D mask

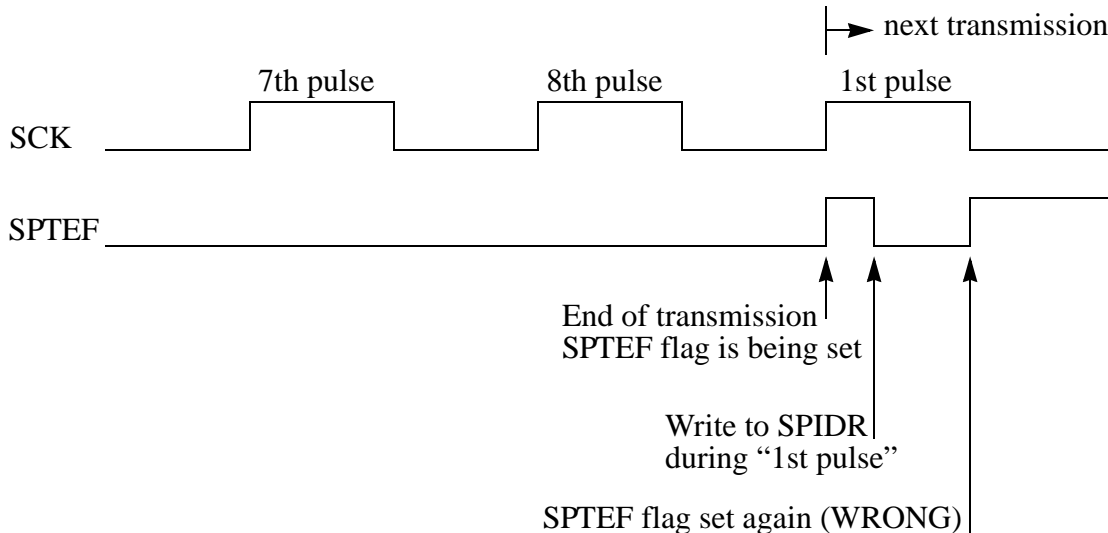
SPTEF FLAG SET WRONGLY**MUCTS00708**

When the SPI is enabled in master mode, with the CPHA bit set, back to back transmissions are possible.

When a transmission completes and a further byte is available in the SPI Data Register, the second transmission begins directly after the “minimum trailing time”.

The problem occurs when, after the SPTEF flag has been set, a further byte is written into the SPI Data Register during the “1st pulse” of a subsequent transmission.

Then the SPTEF flag is set at the falling SCK edge of the "1st pulse" and data is transferred from the SPI Data Register to the transmit shift register. The result is that the transmission is corrupted and data is lost.

After the SPTEF flag has been set, a delay of 1/2 SCK period has to be added before storing data into the SPI Data Register.
