## *Mask Set Errata 1*

# **PC9S12H256 Microcontroller Unit**

- 0K78X mask of the PC9S12H256 and PC9S12H128

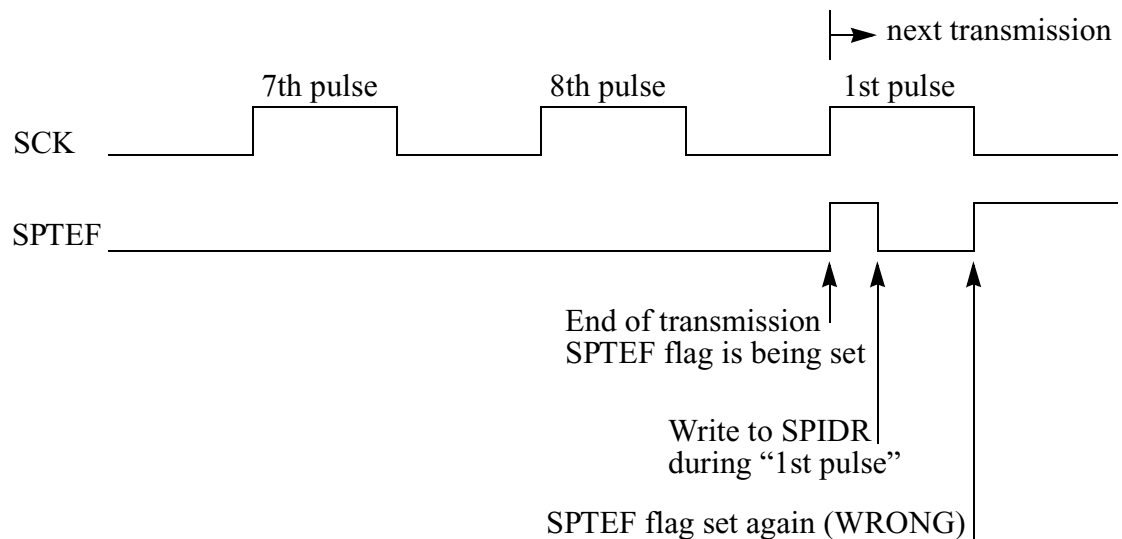
**SPTEF FLAG SET WRONGLY****MUCTS00704**

When the SPI is enabled in master mode, with the CPHA bit set, back to back transmissions are possible.

When a transmission completes and a further byte is available in the SPI Data Register, the second transmission begins directly after the “minimum trailing time”.

The problem occurs when, after the SPTEF flag has been set, a further byte is written into the SPI Data Register during the “1st pulse” of a subsequent transmission .

Then the SPTEF flag is set at the falling SCK edge of the “1st pulse” and data is transferred from the SPI Data Register to the transmit shift register. The result is that the transmission is corrupted and data is lost.

After the SPTEF flag has been set, a delay of 1/2 SCK period has to be added before storing data into the SPI Data Register.
